**REMEDIAL INVESTIGATION
PHOTOGRAPH ALBUM
OPERABLE UNIT NO. 9 (SITE 65)**

**MARINE CORPS BASE,
CAMP LEJEUNE, NORTH CAROLINA**

CONTRACT TASK ORDER 0312

JULY 20, 1995

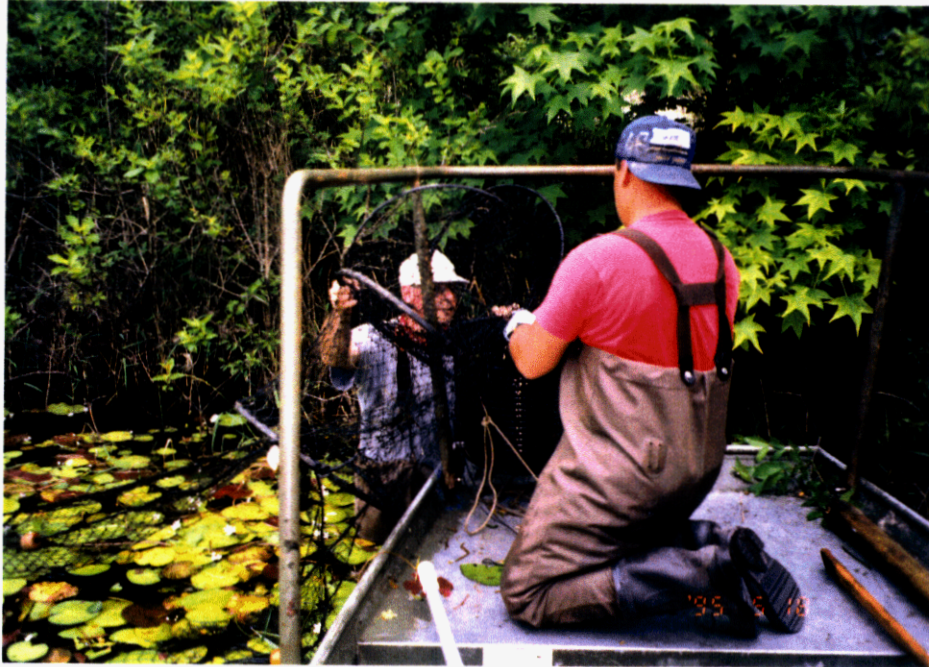
OU9.SITE65.1995.24: Photograph of Baker personnel preparing to set a hoop net in Powerline Pond. Picture taken from Baker boat.

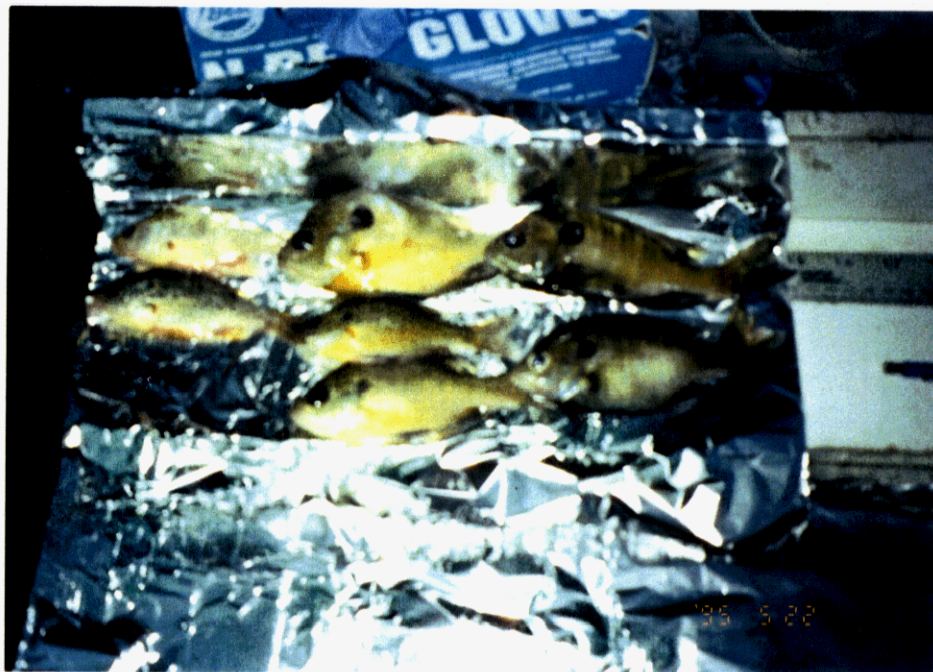
OU9.SITE65.1995.25: Photograph of fish samples caught in Courthouse Bay Pond. Pictured are redear sunfish.
